STATE OF CALIFORNIA
DEPARTMENT of TRANSPORTATION

**OFFICE OF RIGID PAVEMENTS
and STRUCTURAL CONCRETE**

**Route 08
PM 16.9/R35.1**

**SLAB REPLACEMENT AND
DOWEL BAR RETROFIT**

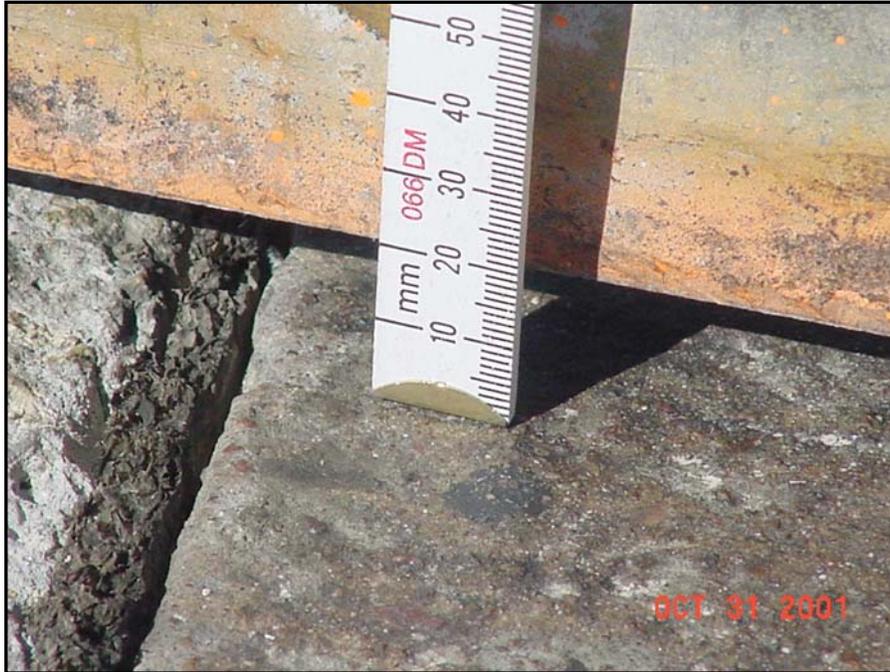
The concrete panels examined during the site visit were located in the westbound direction near post mile 21.3. Many of the panels had a height difference of 8-mm or more when evaluated at transverse joint with a 3.6-m straight edge, even after grinding had been done. The specification limit is 6-mm. In all cases, the leading edge of the replaced slab was higher than the adjacent existing concrete surface (Figure 1). Approximately 90% of the panels exceeded the specification and 50% had developed a transverse crack.

Figure 5. Leading edge of the replacement panel is higher than the existing pavement

The sudden change in profile causes an upward motion in vehicle axles, which then produce an impact load near the location of the observed cracks. Research supports that rough pavement deteriorate faster than smooth pavement.

The length of one of the cracked panels, which matched the existing joint spacing, was measured at 5.7-m. Research has found that panels longer than 5.2-m regularly develop a crack near mid-panel. For this reason, the new standard special provision (SSP 40-020) for concrete replacement has the following requirement:

The appropriate repair strategy depends upon the number of flaws in an individual slab. Slabs longer than 4.6-m that are cracked should be considered as two slabs and treated as such. Slabs with only a transverse crack can be repaired with epoxy or HMWM. Since the cracks tend to be large (>1-mm) and a bound base may be under some of the slabs, epoxy is the preferred material. Slabs with a transverse crack and some other flaw should be considered manifestly flawed and should be replaced.

The elevation of the pavement surface shall be such that water will not pond on either side of the longitudinal contact joint with existing pavement. The new pavement surface at the longitudinal contact joint shall conform as closely as possible to the elevation of the existing concrete. Any difference in elevation between the new pavement and the existing pavement shall be eliminated by finishing the new pavement within 0.3-m of the existing pavement by hand methods, adding or removing Concrete as necessary.

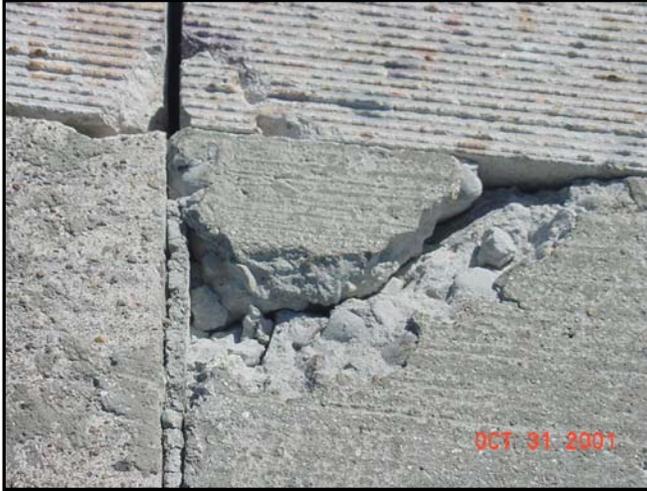
Of the panels inspected, 13% had construction flaws due to careless concrete placement. In one case, the foam board was cut too short to span the entire width panel and caused a

spall to form upon direct contact between the new and old concrete pavement due to thermal expansion (Figure 6). In another case, the foam board placed at the ends of the replacement panel became dislodged and concrete was placed on the wrong side of it, causing the new transverse joint to spall (Figure 7).

Figure 6. Spall due to lack of foam filler material

Other Distresses and spalls in the transverse joints are due to the lack of expansion joint filler.

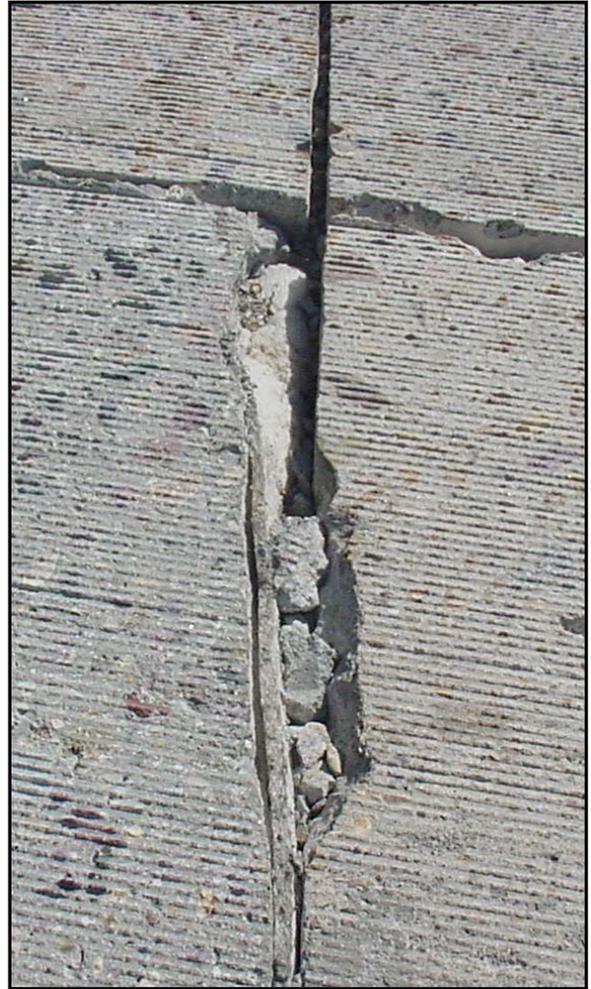
Figure 7. Spall due to poor foam placement.

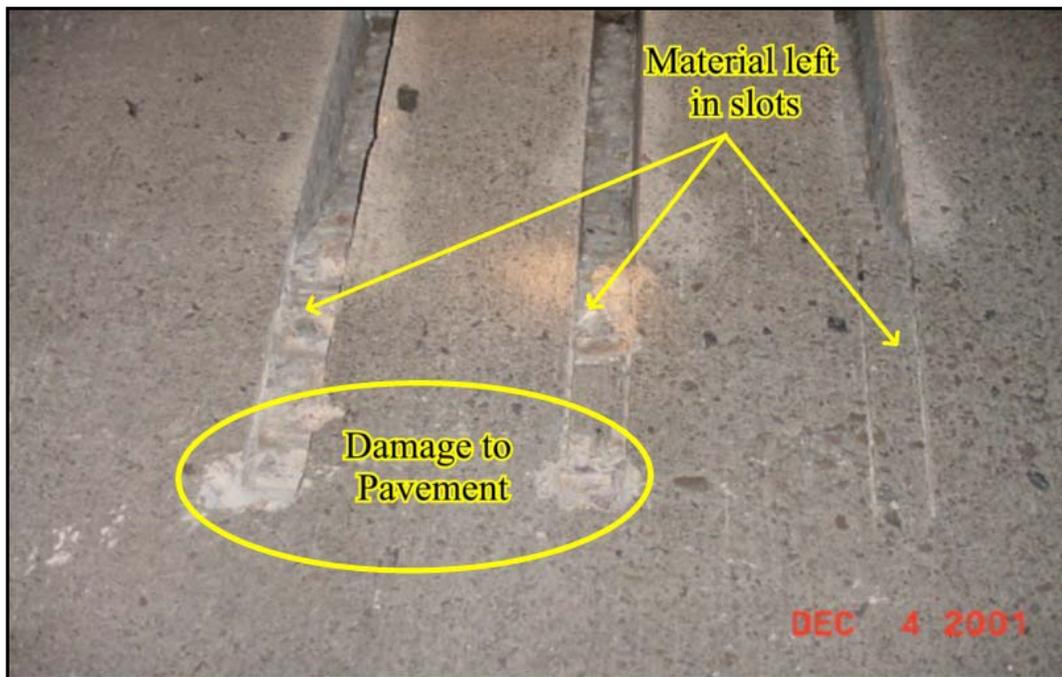
Figure 8. Saw cut slots

Concrete material left in the pre-cut slots was causing damage to the existing pavement (Figure 8). According to the project special provisions (SP), “ slots shall not be cut more than four hours prior to concrete slot removal. After initial slot cutting, no traffic shall be allowed over these cuts.”

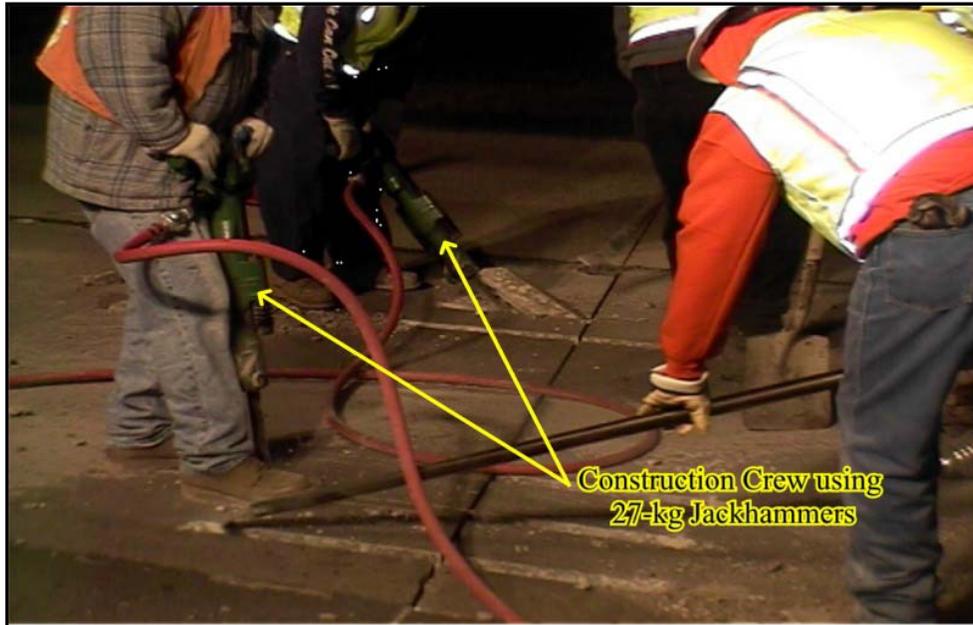
Figure 9. Removal of Concrete from slots

The construction crew was observed using 27-kg jackhammers to remove concrete from the slots (Figure 9). The project SP clearly state:

“Any jack (chipping) hammers used to break loose the concrete between the saw cuts shall not be greater than the 14-kg class. If the 14-kg hammer damages the pavement, the Contractor will be required to use a 7-kg hammer. After removal of large concrete pieces by jack hammering, the Contractor shall use small hammerhead to chip off rocks and burrs from the slot bottom to produce a level surface for dowel to sit.”

“Concrete removal operations and the equipment used to remove the concrete shall not damage the pavement to remain. If the concrete removal operations cause damage, as determined by the Engineer, to the pavement that is to remain, the concrete removal operations shall be discontinued.”

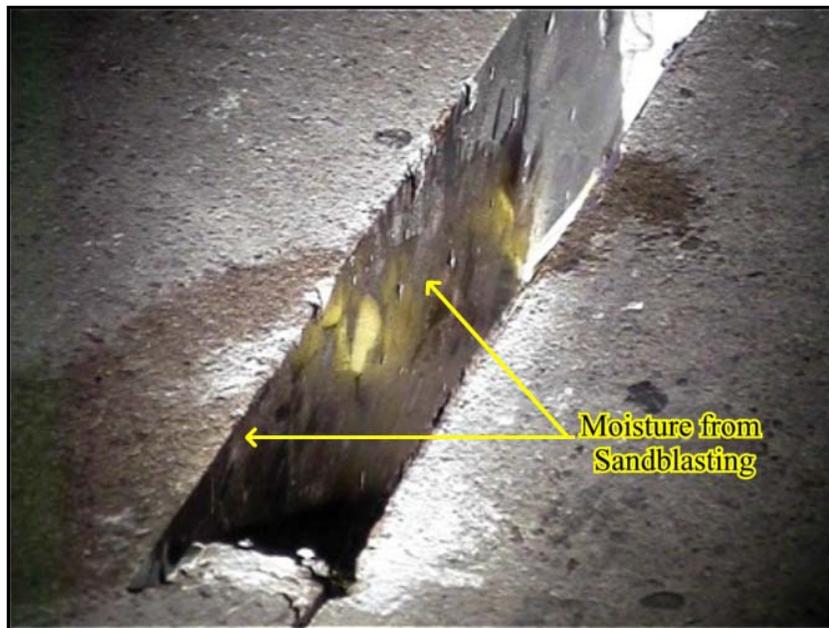
Figure 10. Slot Cleaning

After removing the concrete, the slots were vacuumed and sandblasted to ensure any debris remaining is removed and all surfaces are clean and dry. An inspection of one of the slots revealed that moisture remained after being sandblasted (Figure 10).

From the project SP; “Immediately after vacuuming all debris from the slot, the slots shall be final cleaned with **moisture-free**, oil-free compressed air having a minimum pressure of 620 KPa.”

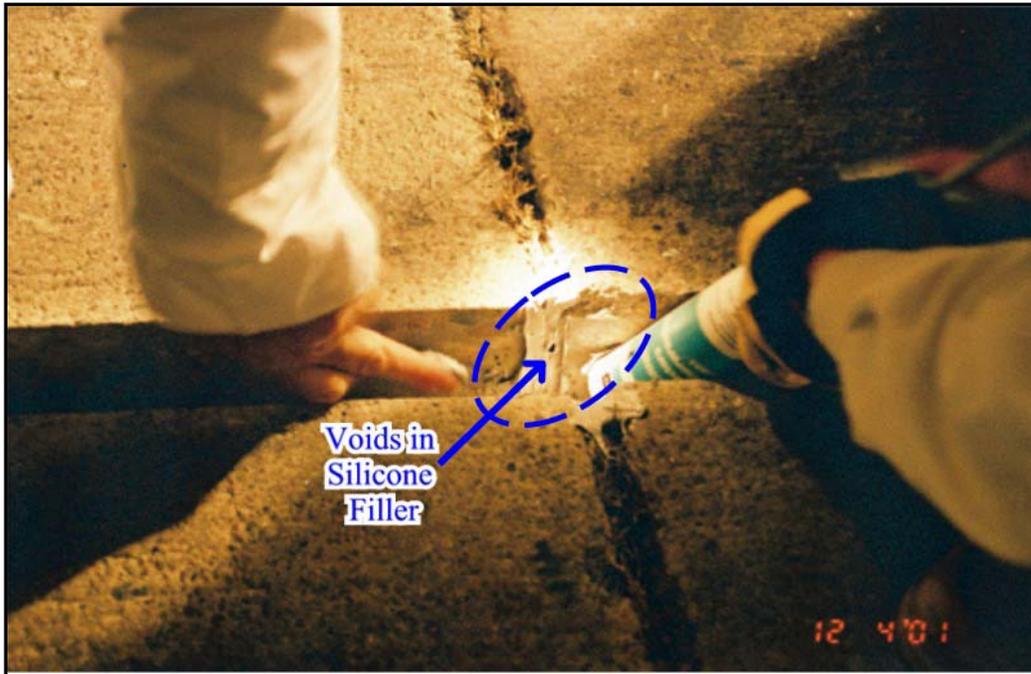
Figure 11. Caulking Filler

In preparing the slots for dowel bar placement, the construction crew used a silicone filler to seal the existing transverse joint within the slot. In one of the slots, voids were noticed in the filler (Figure 11).

According to the project SP; “The Contractor shall seal the existing transverse joint at the bottom and the sides of the slot with caulking filler. This caulking filler shall be placed to a minimum of 13 mm beyond the edges of the slot in the existing transverse joint. Any other cracks within the slot shall also be filled with caulking filler.

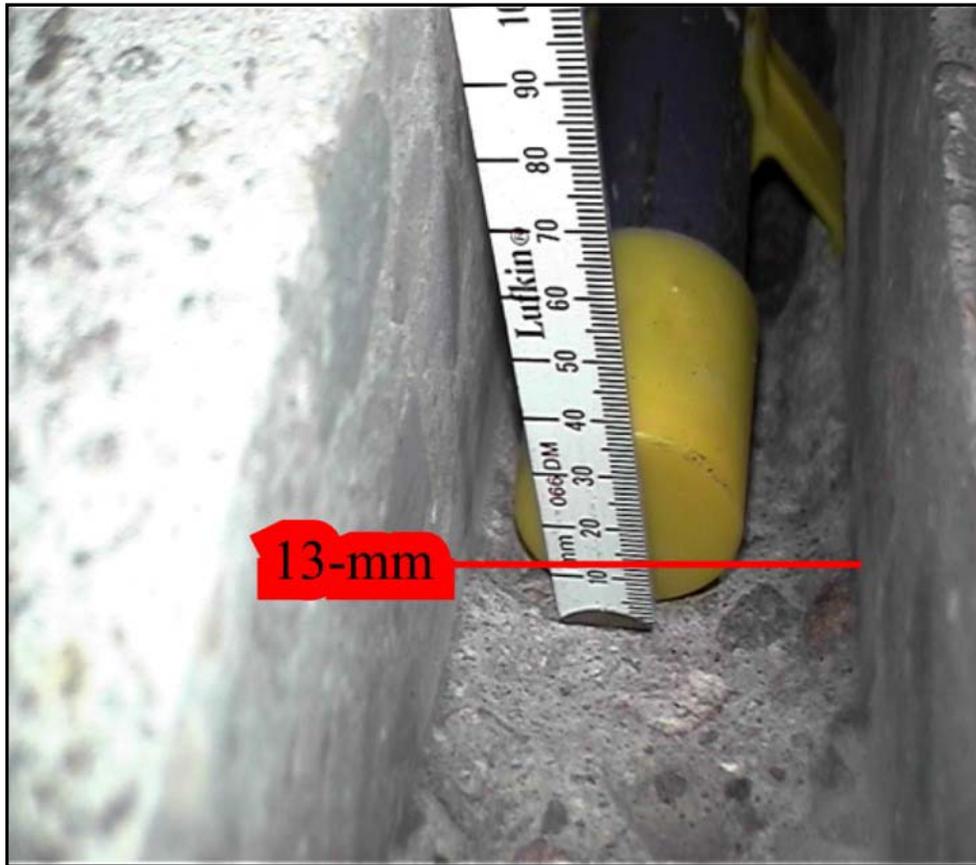
Figure 12. Dowel Clearance

The placement of the dowel bars in the slots revealed more discrepancies. The most obvious was the lack of clearance between the bottom of the dowel bar end and the bottom of the slot.

Some of the slots did not meet the 13-mm clearance required by the project plans and specifications. In one of the dowel bar placements inspected, there was no clearance between the dowel bar end and the slot bottom (Figure 12).

From the project SP; “The (dowel bar) chair shall provide a minimum of 13-mm clearance between the bottom of the dowel bar and the bottom of the slot. The dowel bars shall be placed to the depth shown on the plans, parallel to the traffic lane centerline and the top of the roadway surface, and at the middle of the slot, all within a tolerance of 6 mm. Dowels shall be centered at the transverse joint, such that not less than 205 and not more than 255 mm of the dowel extend into each adjacent panel.”

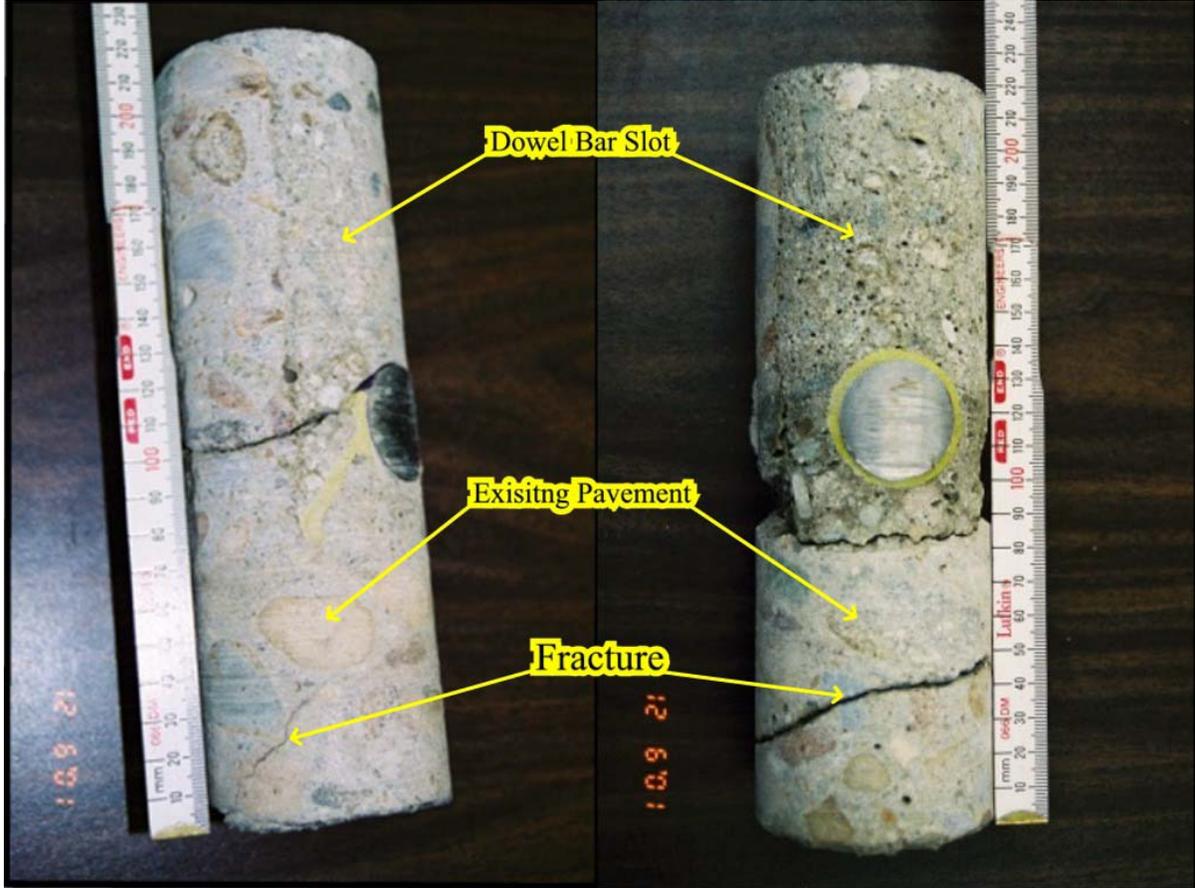
In a meeting with the Resident Engineer on December 6, 2001, core samples from the retrofit installations were examined. A couple cores showed that the existing pavement below the dowel bar slots had been fractured from the use of the heavier jackhammers (Figure 13).

Figure 13. Fractures from using heavy Jackhammers

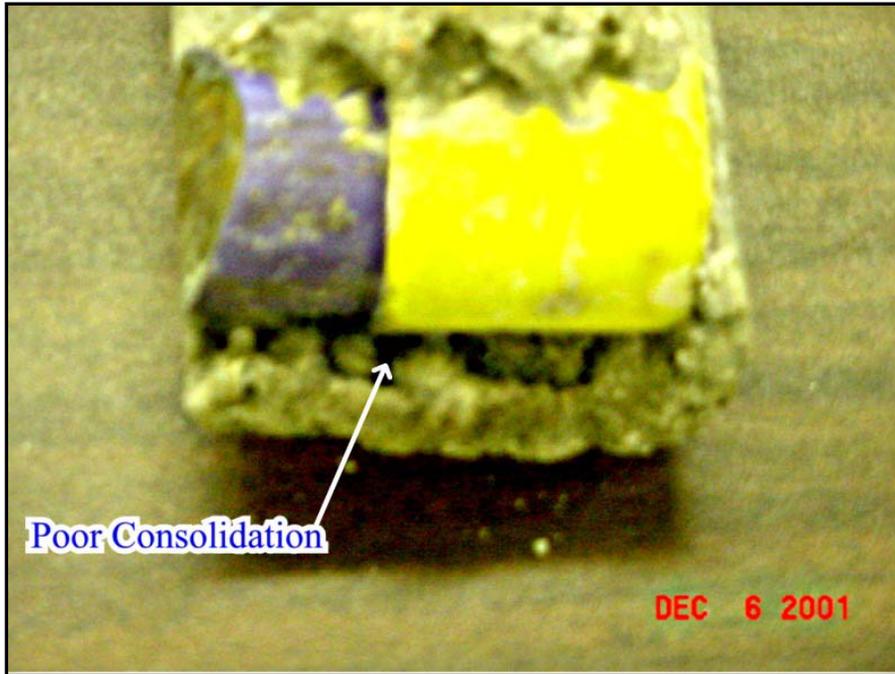
Another core sample showed that fast-setting grout was poorly consolidated around the dowel bar (Figure 14). Numerous voids were evident.

“The grout shall be vibrated with a small hand held vibrator capable of thoroughly consolidating the grout material into the slot and around the dowel bars. All grout shall be placed while fresh, and before the grout has taken an initial set.

Figure 14. Consolidation of Grout Material

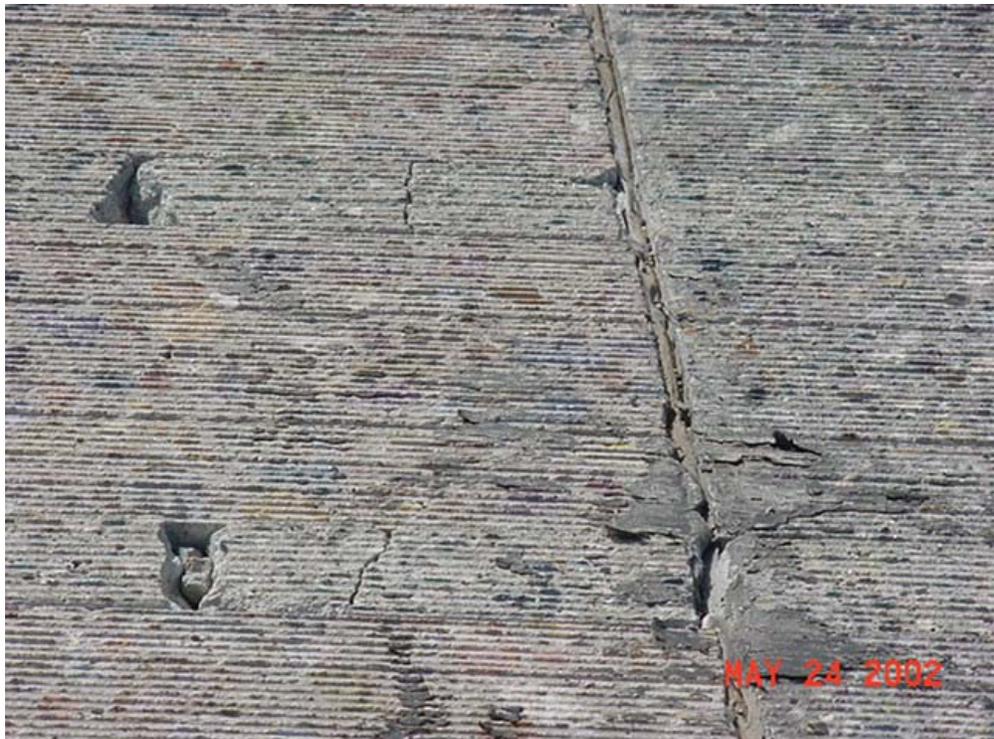
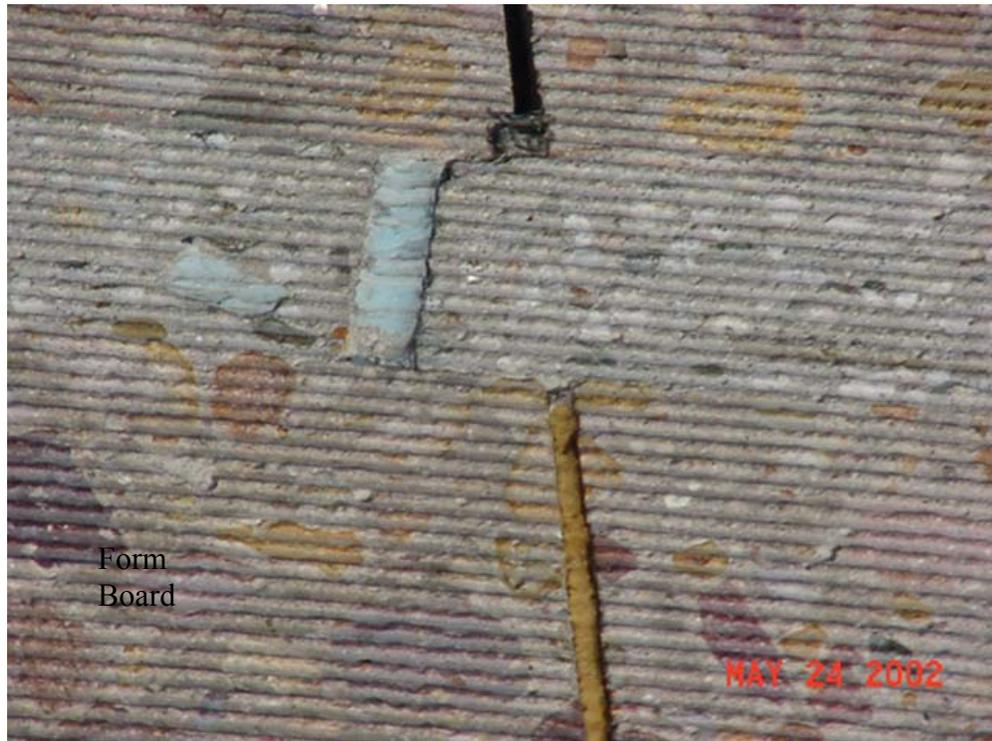
1. Dowel bar slots were constructed incorrectly.
2. Foam boards were not aligned with existing transverse joints.
3. Sealant was not being applied in the transverse joint

Figure 15 Foam Board Misalignment
